METHANE FROM FLARING TOOLKIT

Flare Design: Flare seals – Molecular (buoyancy) and Velocity Seals

How is the flare designed to minimise methane? > Flare Design: Flare seals – Molecular (buoyancy) and Velocity Seals

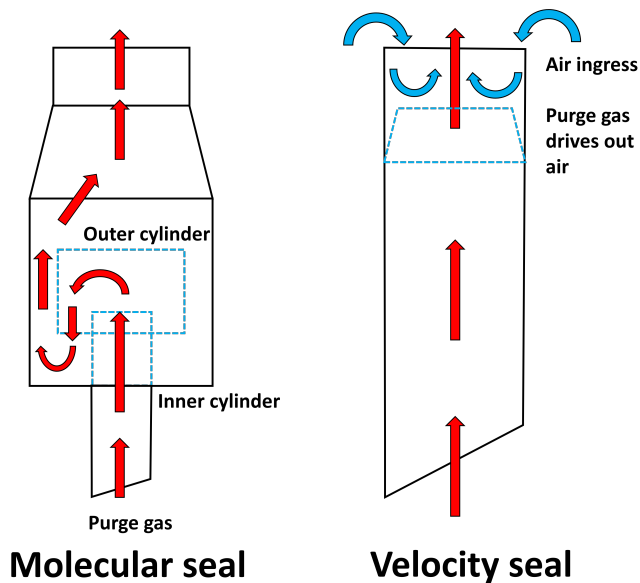
Molecular or buoyancy seals employ a tortuous path technology and the density difference between air and the purge gas to prevent air backflow. The purge gas tends to accumulate in the high or low spots, depending on whether it is lighter or heavier than air, and form a seal.

Velocity seals require the purge gas to flow through a reduced diameter throat so that its velocity increases, preventing air ingress past the throat and entraining any air accumulated above the throat out of the tip.

- Molecular or buoyancy seals
 - Reduce purge gas to 0.003 m/s
 - Reduce purge gas volume by 98%
 - Require more capital than velocity seals
- Velocity seals
 - Reduce purge gas to 0.006 m/s
 - Reduce purge gas volume by 94%

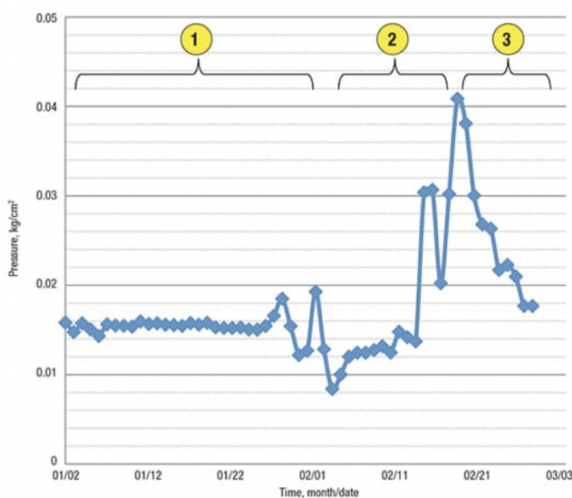
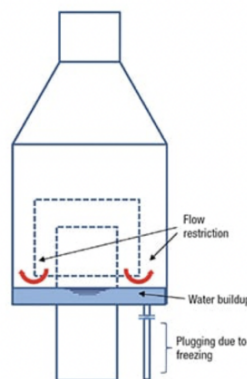
FIGURE 3. The graph (above left) shows the pressure profile of a flare header (which remained fairly static at first, but then rose suddenly). The figure (above right) shows the water buildup in the flare molecular seal. As the graph indicates, water was building up in the molecular seal drain line during the month of January (the portion of the graph labeled 1). An abrupt increase in the flare header pressure during the middle of February (graph segment 2) indicated the presence of plugging due to freezing. By March, the pressure had returned to normal, once the ice had been cleared (graph segment 3)

In this case, freezing of the molecular drain line caused a pressure increase on the flare header, and it was beginning to approach the design limit. All of the process units that feed offgas to the flare had to prepare for potential shutdown (since none would be allowed to operate without proper waste gas disposal). When analyzing the pressure data on the header, it was found that the pressure had been relatively static for nearly a month and a half, although a slight upward trend was barely noticeable until it suddenly increased sharply (Figure 3).

The abrupt spike shows that there was no gradual increase; rather, the drain line was plugged. If the pressure had been rising slowly and continuously then steps could have been taken to shut down all related process units

feeding the flare. We had two options — one was to prepare an unscheduled plant shutdown, and the other was to clear the pressure buildup problem over the course of one week while the system was still operating. However, over the course of the week, the pressure could have exceeded the design limit. Unfortunately, many operators typically have no experience dealing with drain-line plugging resulting from icing. The molecular seal drain is provided to drain water that is created during operation by steam condensation. Drain line plugging becomes apparent when the drain valve is open and no water flows at all. When operators fully understand the proper function of the molecular seal system, they will respond immediately to a pressure buildup in the header by checking the drain water to discover or rule out a blockage from ice formation. But in this case, no one at the facility had a clear understanding about the plugging of the molecular seal drain line, once the header pressure began increasing. During the cold winter season, condensation will occur at both the center steam-injection point and the upper steam-injection point at the flare tip. The center steam helps lift the flame and the upper steam enables smokeless flaring. Small parts of the center steam will condense when the shell of the flare tip is cool enough and the atmospheric temperature falls. The condensate drips down along the inside shell of the flare tip and accumulates at the bottom of the molecular seal drum. If there is no proper drainage, then this condensed water can build up, freeze and eventually block the offgas route. Upon making a close inspection all along the drain line through the stack height, there was one area (around a 1-m span out along the drain line) where the insulation had slipped away near the bottom of the thermal-expansion loop. The steam tracing was still operating, but because the insulation had slipped on a portion of it, the bare piping was still prone to icing during cold winter days (freezing temperatures of -10°C were common). In order to melt the ice buildup, the low-pressure steam was serviced through the drain line bottom connection. However, we had to spend more than two days clearing the plugged piping while the flare was still operating. Due to the limited access near the flare tip during operation, the damaged insulation could not be repaired during this effort, so we had to rely on intermittent service of steam to periodically remove the ice buildup throughout the winter season. We had to wait to repair the insulation during a scheduled turnaround, and had to spend more than \$0.8 million for scaffolding work all along the 120-m stack height to access the right point. Considering the importance of the molecular seal drain line, it is important to prepare and maintain vertical piping insulation carefully...
